AN INDEPENDENT REFINER'S APPROACH— PRACTICAL SOLUTIONS TO COMPLEX GEAR PROBLEMS

John B. Cary

Reliability Superintendent—Avon Refinery
Tosco Refining Company
Martinez, California

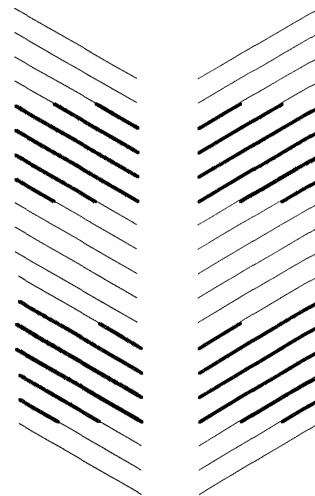
principally on the pinion at five tooth intervals, repeated every five teeth (Figures 2 and 3).

Figure 2. Cyclical Wear Pattern on Pinion Circumference.

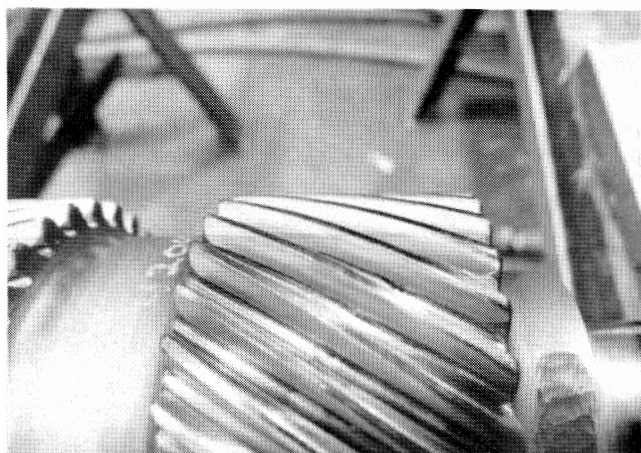
Figure 3. Photo of "Banding" Pattern on Pinion Teeth.

In 1969, a replacement set of gears was received and installed. An unusual banding pattern was observed on the gear and pinion that had been in service. This is the first time the unusual wear pattern had been seen, encompassing four or five teeth and repeating itself every four or five teeth all the way around the pinion.

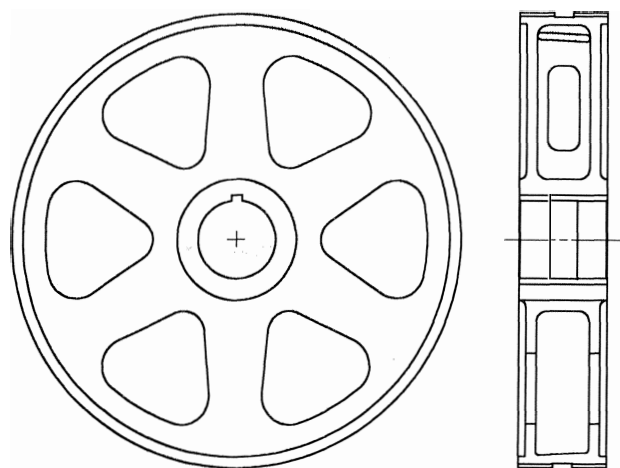
Figure 4. Original Spoked Gear.

In 1968, the gear failed catastrophically. All the teeth were shucked off one flank, and half the teeth were missing from the other. NDE revealed every fourth or fifth tooth on the gear was cracked at the root. Two spokes were cracked—one at the hub and one at center span. (The significance of these observations was not unveiled until later and will be discussed herein.)

At the time, the company had no spare for the gear available, so the gear was flown to the factory for repair. The spokes were welded, new teeth were cut and a new pinion was built. The gear was flown back and reinstalled. (This entire process was accomplished in only 11 days!)

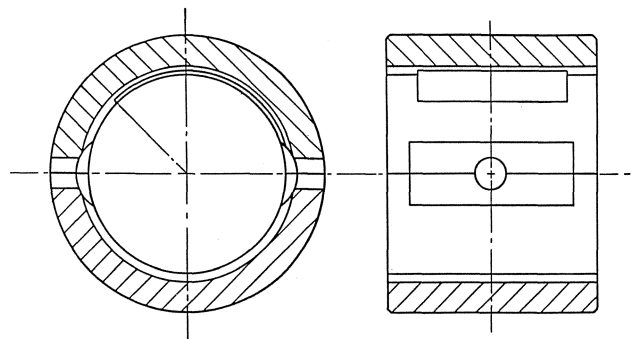
Based on the original design for torque, gear weight, and pinion reaction forces, the assumption was made that the gear would remain in the upper quadrant of the bearing under normal load conditions. Because the gears were down mesh, upward torque preload was supposed to exceed journal dead weight. In 1972, one proximity probe was installed in the axial position on the free end of the pinion. It revealed tremendous shuttling in excess of eight mils. The conclusion was drawn that the gear did not have sufficient torque loading to remain in the upper bearing quadrant. This in turn caused the gear shaft to lose the stability provided by the hydrodynamic forces generated by the oil film. This resulted in a shaft instability that created a torque induced couple motion, which caused the gear to "wobble."

Figure 6. Pressure Dam Bearing Used In Lower Half of L.S. Bearing.

To correct this problem, the OEM suggested the installation of a "Rayleigh Step," known today as a pressure dam, in the bottom half of the gear bearings. (Figure 6) It was felt this would provide the additional upward force required to keep the shaft in the top half of the bearing, as per the original design assumption.

The recommendation was to put the pressure dam in the upper half of the gear bearing to work with gravity to hold the bearing down. The new pressure dam bearings were installed in 1979. This change had some stabilizing effect, but the noise and vibration levels continued to propagate.

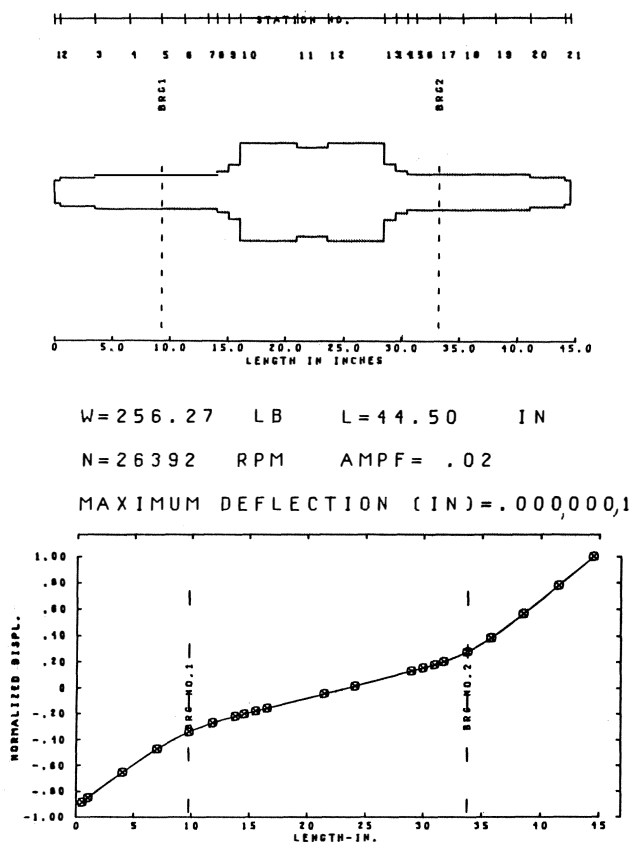
In 1980, a new reformer unit was commissioned. This caused the purity of the recycle hydrogen to improve again, unloading the gear further, increasing its instability. The pinion shuttling mode increased, as it tried to follow the wobbling path of the gear face. The severe axial impact created by this process excited the second critical speed of the pinion.

Figure 7. Pinion Model and Unbalance Response.

The final bearing change was performed on the pinion, in an attempt to move the critical out of the excitation range. Using finite element analysis, a pinion model was created (Figure 7). The model was then used to determine the optimum stiffness required to move the critical mode outside the operating range. A five pad tilt-pad bearing appeared to have the best chance for stabilizing the pinion. The bearings were installed and tested but analysis of the test data revealed a reduction in the critical speed of merely six percent, which did not stiffen the pinion enough to move the critical outside the operating speed.

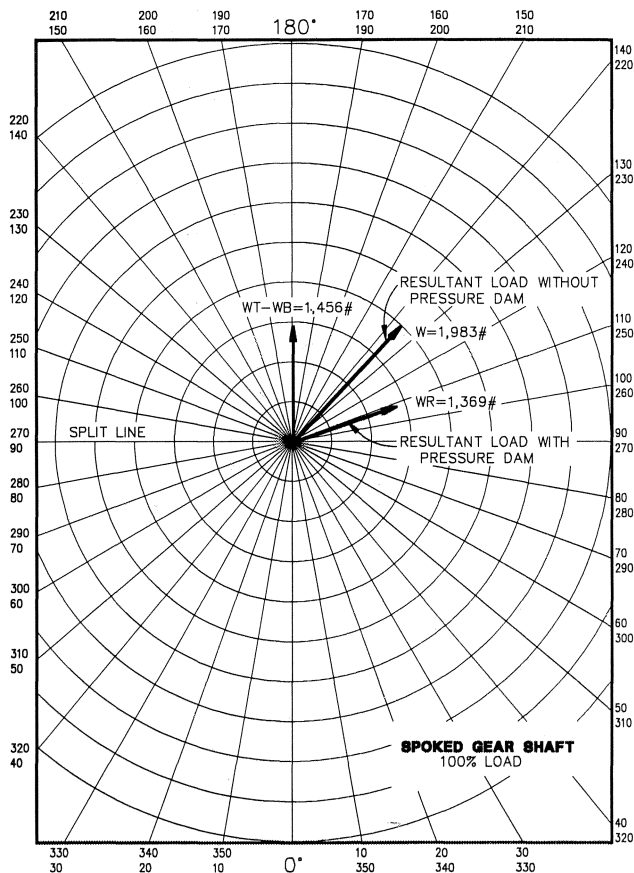
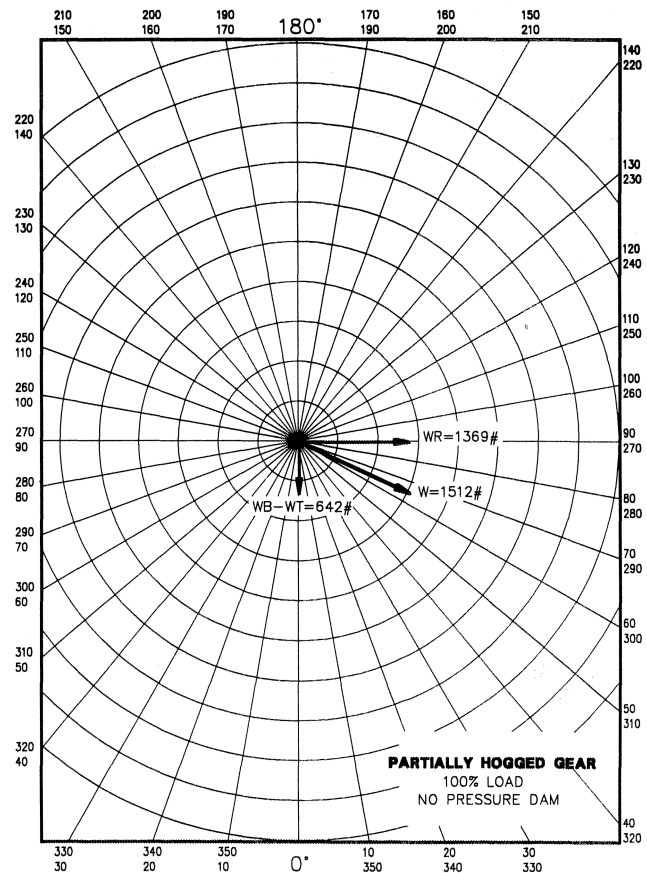
The results of the bearing load analysis are shown in Figures 9 and 10. For each bearing, the total load is the vector sum of the static weight of the rotor and the gear reactions. Gear reactions include the transmitted load, which is tangential to the pitch circle, the radial load, or separating force which is normal to the pitch circle, and an axial component which is equal to zero in this case since the gears are double helical. The old gear is shown in Figure 10, with the load very close to the split line. This is an unstable region due to the presence of the oil distribution groove, and could contribute to instability. The gear chosen to replace the existing unit is shown in Figure 10. Notice at 100 percent load the resultant vector (W) remains in the lower quadrant.

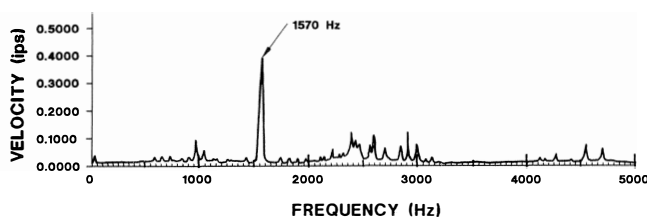
Figure 12. Spectra Showing 1570 Hz Gear Resonance.

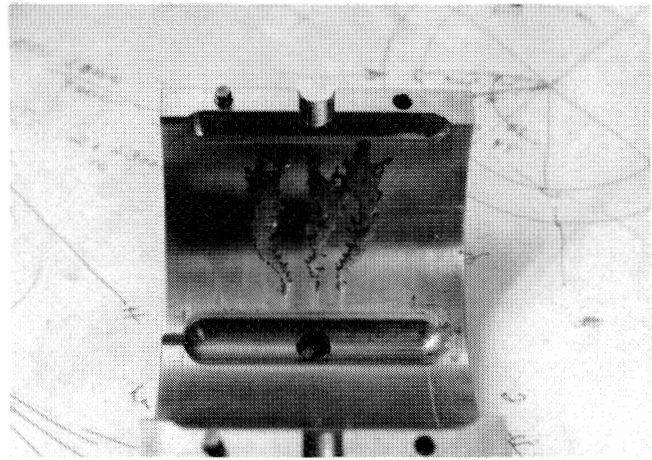
The pinion bearings were severely damaged. This damage was initially thought to be electrostatic discharging, but was later identified as cavitation. (Figure 13) The gear bearings showed incipient signs of cavitation as well.

Figure 13. Cavitation Damage to High Speed Bearings.

To improve wear resistance, the trimetal bearings were installed, and the lube oil was changed from turbine oil with an ISO rating of 32 centistokes, to an ISO 46 AW (antiwear package) turbine oil.

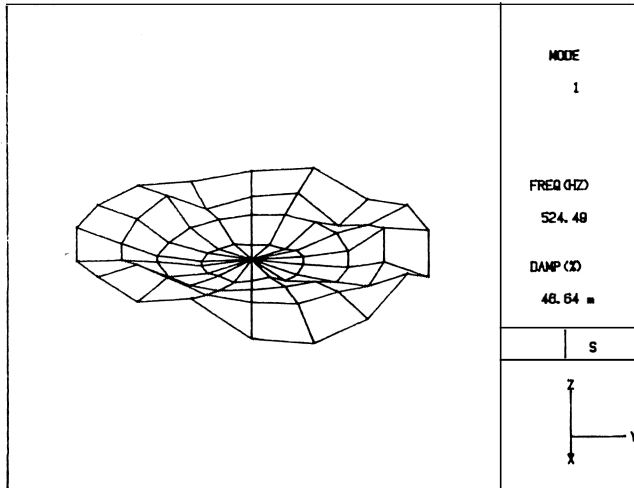
In summary, the study identified three principle modes, of which the lowest 524 Hz mixed mode of umbrella and edge scalloping appears to be the most closely related to the observed wear pattern (Figure 15). This component is close to a sometimes prominent operating response at 480 Hz, seen in the gear data under advanced wear conditions, and is also close to a critical speed of the pinion as determined by earlier analysis.

Figure 15. Scallop Mode Shape at 524 Hz From Partially Hogged Gear Modal Analysis. Pinion second critical resides very close to this frequency domain. Note non-synchronous nature of the scallop shape at the gear periphery.

The composite modes exhibited in the profiled gear at 524 Hz were those of an umbrella mode coupled with approximately 3.6 scallops around the periphery and could be synchronized with the excitation force. It is the interplay between this function and the pinion critical (at or about three times operating speed) which represents the most likely wear mechanism.

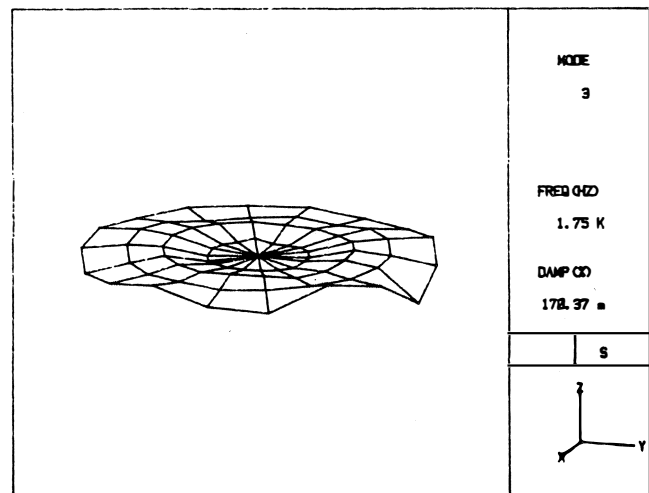
The impact testing also indicated principle gear responses at 1,750 Hz and 4,110 Hz. (Figures 16 and 17) The former frequency was identified as the first umbrella mode during the design review by the gear consultant, but is definitely a second order umbrella mode. The degree of scalloping at the edge is minimal, and the frequency is not consistent with any known mechanism which could produce the "banding" type wear pattern.

Figure 16. Initially Identified as the First Umbrella Mode, Impact testing revealed this response at 1,750 Hz to be a second order umbrella mode, not attributable to a banding pattern.

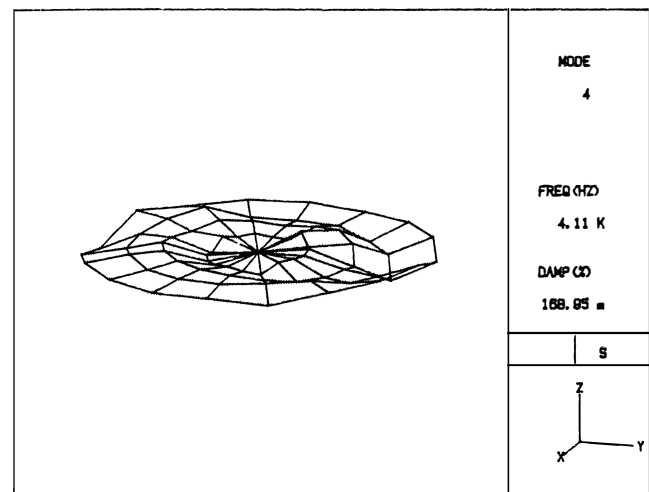
The high frequency 4,110 Hz mode was of interest because of its proximity to the actual gear mesh frequency of 4,300 Hz. However, this mode was found to be another higher umbrella mode of the 3rd or 4th order, and did not correlate with the generation of the wear pattern. This mode is lightly damped, which

Figure 17. 4,110 Hz Mode is Close to Gear Mesh Frequency. Testing found it to be a third or fourth order umbrella mode. Its light damping could accelerate wear, but was not responsible for the banding pattern.

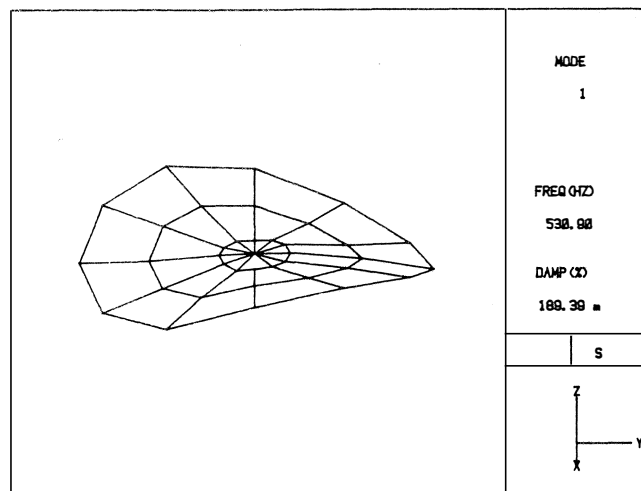
Some interesting results emerged from the impact testing. First, the scallop mode shape at 524 Hz on the partially hogged gear is nonexistent in the unhogged disc. Instead, the unhogged disc at 530 Hz exhibits a much more symmetrical mode shape

comprising two sine wave patterns at the periphery of the disc, with no perceptable axial (umbrella) type motion observed (Figure 18). Axial motion, described as cymbal or umbrella motion, is greatly reduced on the unhogged gear at all mode frequencies.

Figure 18. The Unhogged Disc at 530 Hz Exhibits a Much More Symmetrical Shape, Characteristic of a True Umbrella Mode.

The results of impact testing clearly corroborated the fact that the partially hogged gear was not suitable for reliable longterm operation. The testing also indicated that the blank forging may provide a viable alternative solution, at least in the interim, until another gear design was developed.

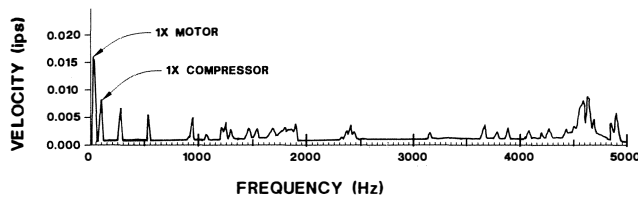
A complete set of vibration signatures was acquired in March 1989, after the unit reached normal operating condition. The results indicate the gearbox performance with the new elements is excellent, with good synchronous and gear mesh responses. Pinion stability appeared good and the gear wobble observed in the past was much abated. The resonance response primarily responsible for poor gear performance in the past was undetectable and it is assumed that the radical design changes have successfully eliminated this problem. This belief was further reinforced when the annual followup analysis, conducted in March 1990, indicated little or no deterioration based on comparison with previous data. The absence of the resonant frequency response is shown between the hogged and unhogged gear in the vibration spectra (Figure 25).

Figure 25. Most Recent Vibration Spectra From the Unhogged Gear Show the Absence of Harmful Resonant Frequencies.
